## CONTROL-SURFACE INSTABILITY ON HIGH-SPEED AIRPLANES

June 1942

CONFIDENTIAL BULLETIN

By William H. Phillips

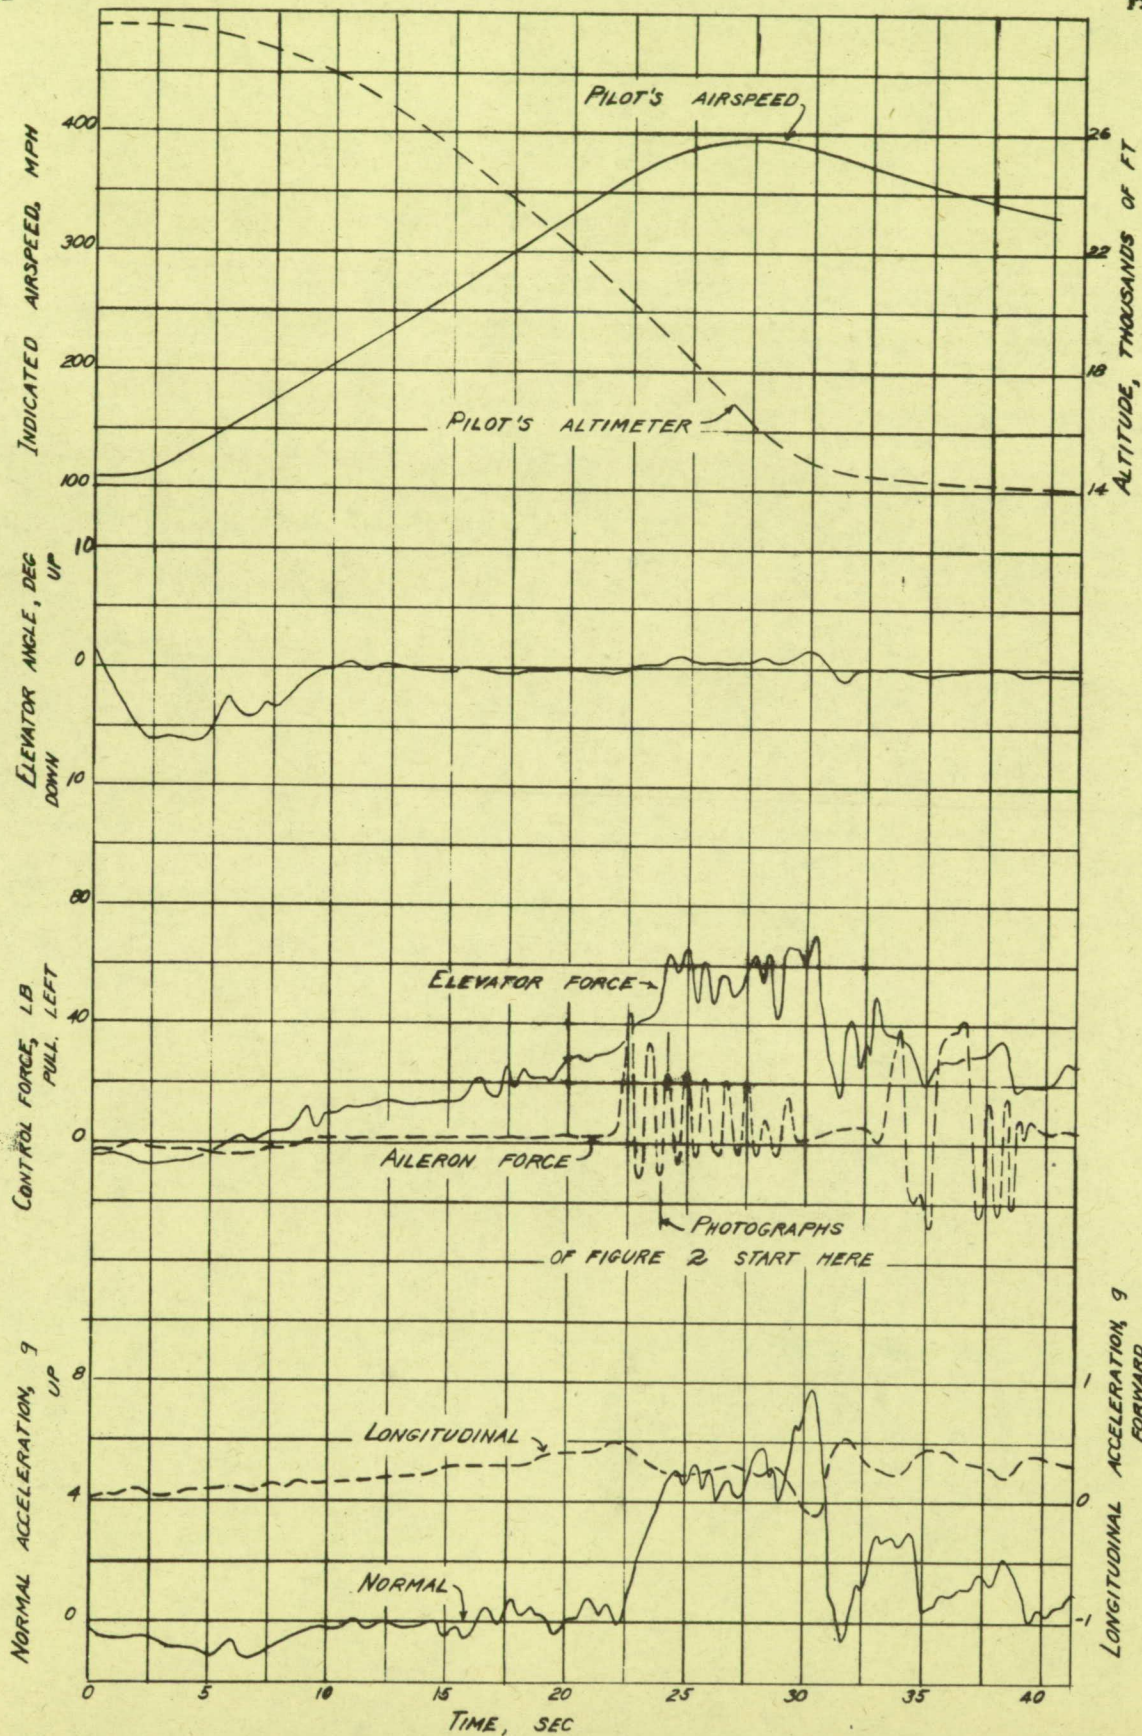
FIGURE 2.— SEQUENCE OF EVENTS SHOWING AILERON INSTABILITY  
IN ATTEMPTED TERMINAL VELOCITY DIVE.

Tests of several modern airplanes indicate that control surfaces with a high degree of aerodynamic balance are likely to possess characteristics which make them unsatisfactory or dangerous in high-speed flight. Dive tests made in the spring of 1940 at the NACA on a naval fighter-type airplane illustrate one form of instability that may be encountered. During a dive at an indicated airspeed of 365 miles per hour, the ailerons suddenly overbalanced. The efforts of the pilot to bring the ailerons back to neutral resulted in a violent oscillation of the control stick from side to side. Fortunately, the force required to return the ailerons to neutral was within the pilot's capabilities. A time history of the maneuver is given in figure 1 and typical frames from motion pictures of the cockpit and of the wing, taken during the maneuver, are given in figure 2. In the illustrated case, the occurrence of aerodynamic overbalance was attributed to a slight bulge, approximately 1/16 inch thick, on the lower surface of the leading edges of the ailerons, caused by the installation of additional mass balance ahead of the hinge line. A drawing showing the shape of the bulge is given in figure 3. After this slight protuberance had been eliminated, dives were successfully made at higher speeds.

STICK LEFT  
AILERON DOWN 5 DEG.  
FORCE RIGHT = 10 LBS.  
TIME = 23.8 SEC.

STICK MOVING RIGHT  
AILERON MOVING UP

STICK NEUTRAL  
AILERON NEUTRAL  
FORCE LEFT = 4 LBS.  
TIME = 24.0 SEC.

STICK RIGHT  
AILERON UP 10 DEG.  
FORCE LEFT = 24 LBS.  
TIME = 24.2 SEC.

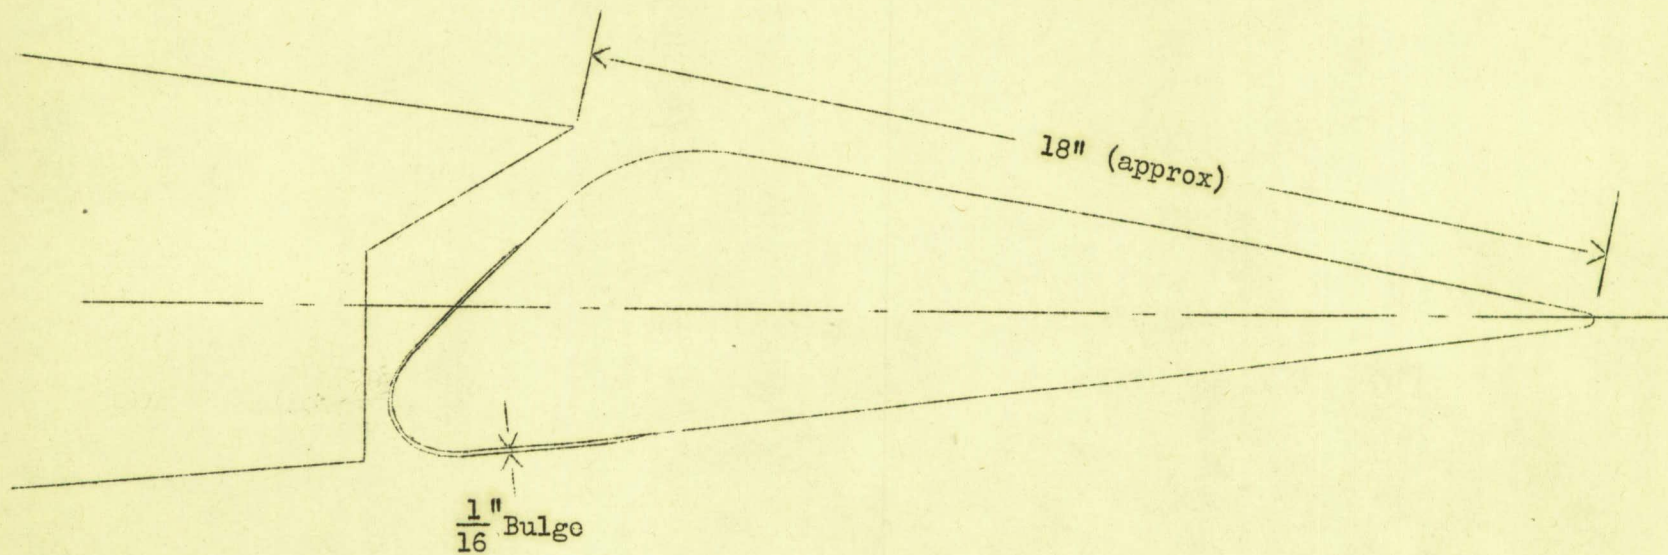
Figure 3.- Diagram showing size and location of bulge on Navy fighter-type aileron.
